Discoloration of Cracks

Spring is a time when many **sealcoat contractors** face the challenge of **crack discoloration**.

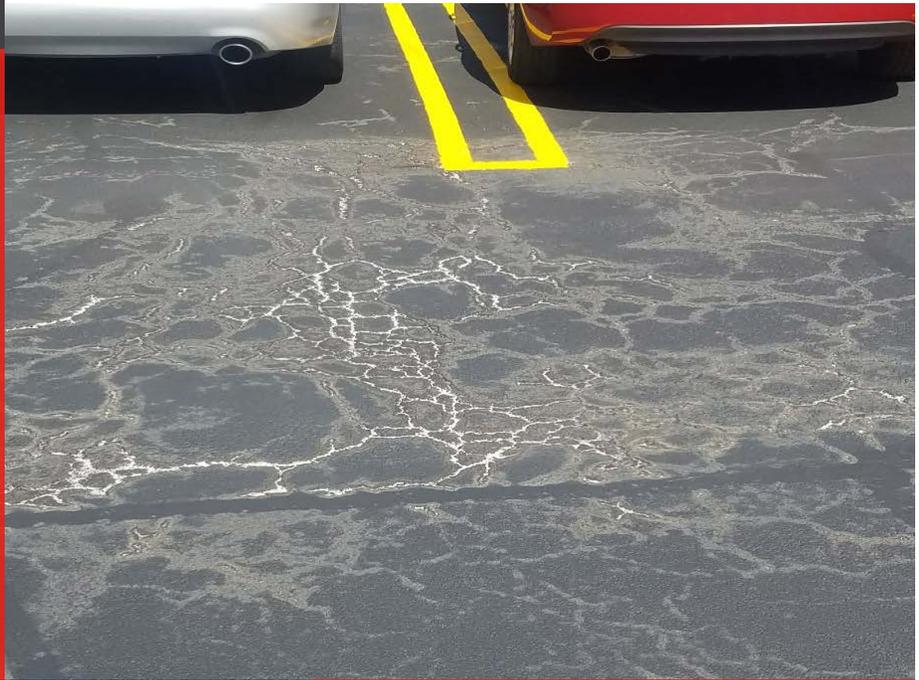
Crack discoloration is a common issue that arises when water comes up through the pavement where cracks or pavement failure is occurring. As the days get warmer, the sun heats up the pavement and draws the moisture back to the surface.

If you sealcoat a parking lot and notice that the cracks, alligatored areas or low spots in the pavement have a discoloration of the sealer, typically brown, that is due to the sealer re-emulsifying. In other words, the sealer reabsorbs the water.

Sealer cannot form its film if there is constant water present. The use of additives can help reduce some staining, but remember this is not a sealer problem, this is a water problem.

To avoid damage caused by the crack discoloration process, water must be prevented from going underneath the pavement.

Developing a plan for crack sealing and patching failed asphalt as well as a careful evaluation of drainage patterns can minimize the appearance of discoloration and the damage that coincides with its development.

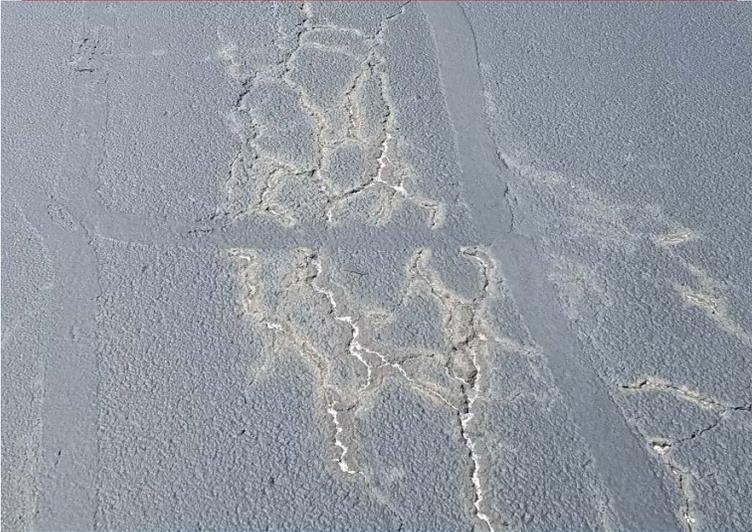
White coloring may also be seen in the cracks or white staining on the surface due to salts. These salts are from winter deicers resulting from excessive use of salt on parking lots during the winter months or from natural earth salts coming to the surface known as efflorescence.

The white stain is most common on pavements composed of limestone materials and is caused by the leaching of limestone dust from the base materials that lie just beneath the blacktop surface.

When spring rains seep beneath asphalt, they are later pulled back up to the surface by the sun's heat. As the water evaporates, it can leave behind a white or yellow mineral deposit in the cracks or on the pavement surface. These stains or deposits are usually washed away over time. Typically by fall, most have disappeared.
